Navajo Abandoned Uranium Mine

Site Screen Report

Jackpot No. 40 AUM Site

January 2011

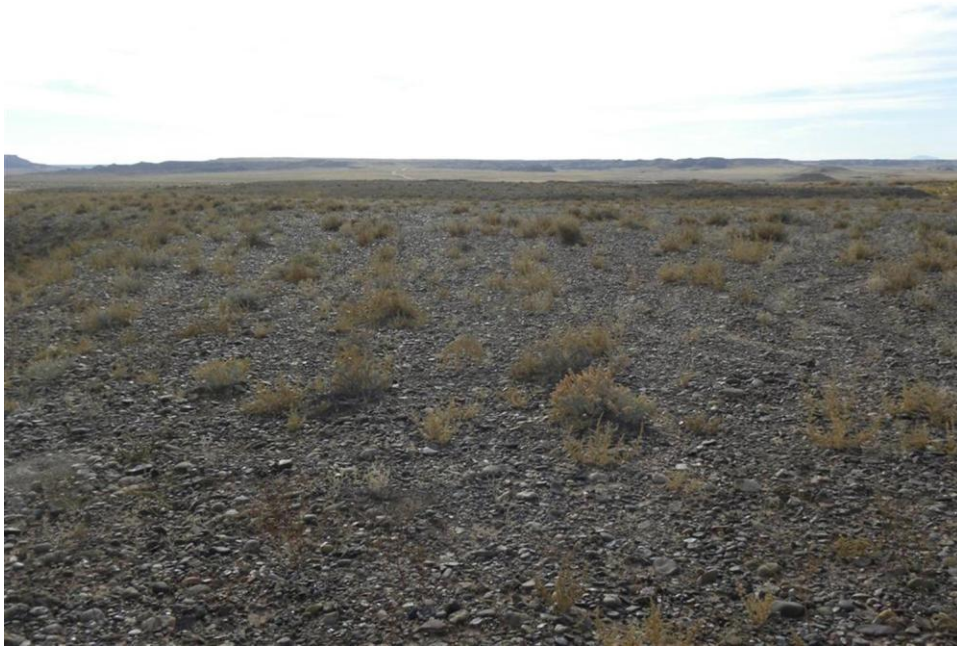
Photo 1. Jackpot No. 40 mine site

Some possible reclamation on SW side of site, graded soil sloping downhill

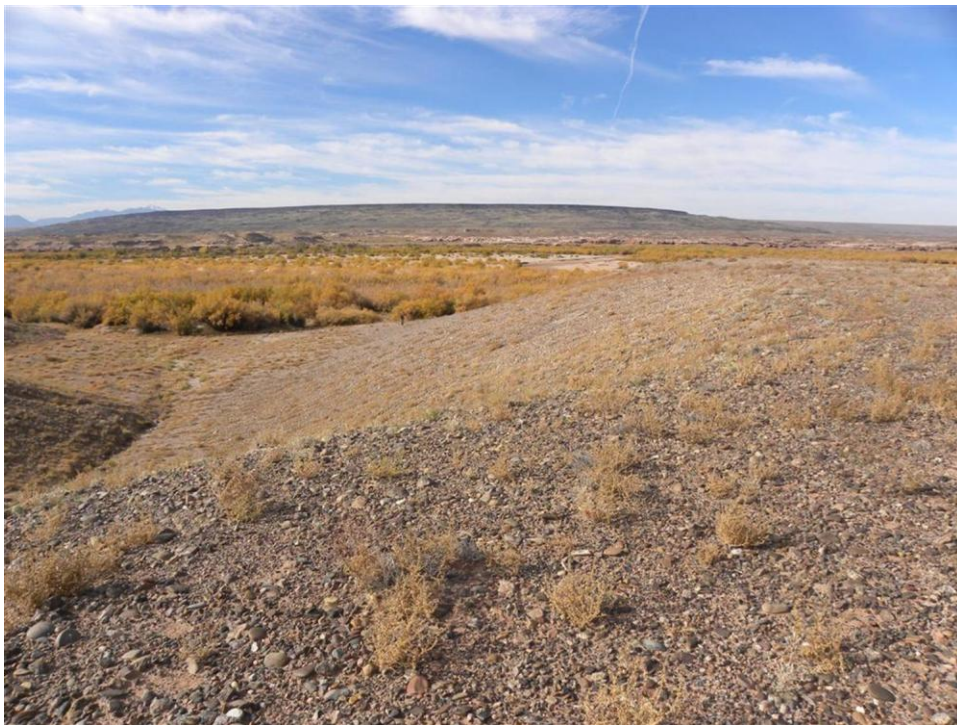
Photo 2. Jackpot No. 40 mine site, sloping towards the Little Colorado River

Little Colorado River Basin adjacent to the W of the site, possible wetlands
